Inspection Report
Minerals Regulatory Program

Mine Name: Diamond Mountain
Operator Name: Deseret Generation and Transmission
Inspector(s): Paul Baker and Doug Jensen
Other Participants: None
Mine Status: Active (inactive at the time)

Permit number: M0470066
Inspection Date: April 13, 2006
Time: 3:30-4:10 PM

M0470066, Diamond Mountain Quarry, Deseret Generation and Transmission

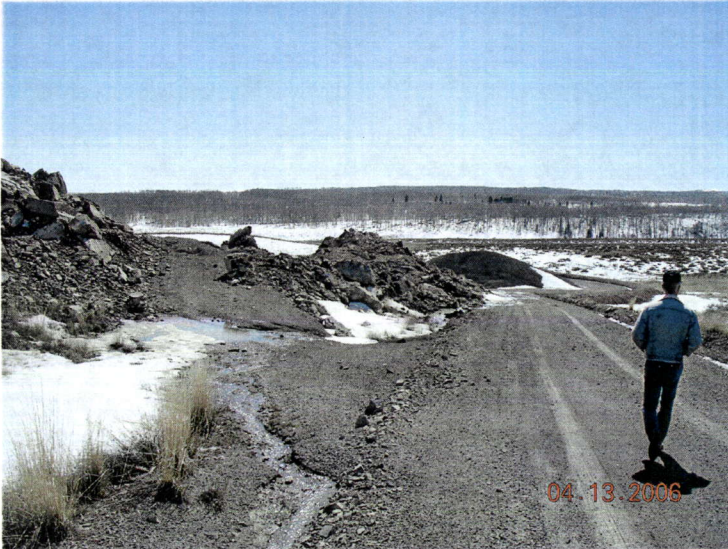
During the inspection, there was a lot of snowmelt water running through ditches on the sides of the road, across the road, in a ditch to the west of the site, and elsewhere. On the west side of the mine, there are ditches on either side of the road and another below the outslope of the road. The ditch on the east side of the road was blocked so water was forced to run across the road (Photo 1).

Photo 1. The ditch and a culvert on the left side of the road were blocked forcing water to flow across the road.

I recommended to Mr. Jorgensen that a culvert be installed under the road on the west side of the mine to divert water from the east to the west side of this road. He sent a picture showing a culvert that is already under the road on the west side of the mine, but this culvert was not functioning because of some debris in the ditch where the inlet is located. This debris needs to be cleaned out.

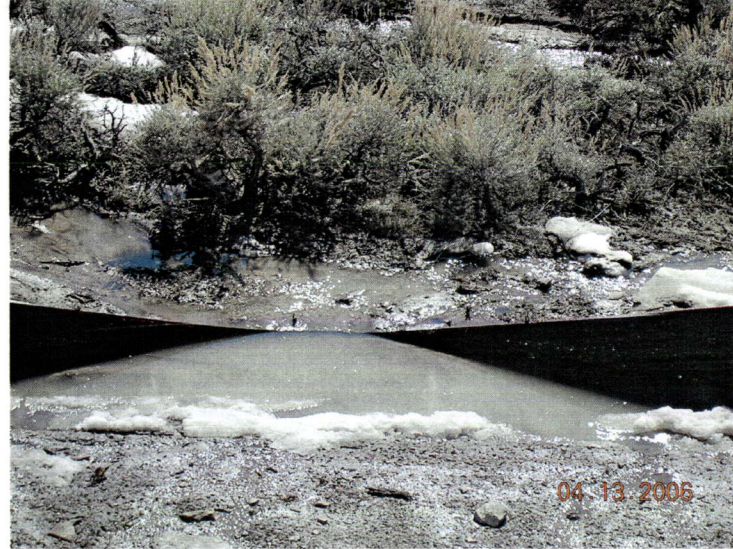
There is another ditch at the bottom of the outslope west of the west road, and water flowing in this ditch does not go into the sediment pond. Rather, it flows to a silt fence then into Reader Creek, but most of the water was flowing under or over the silt fence rather than through it (Photos 3 and 4).

Photo 3. Silt fence below the sediment pond.

The silt fences needed to be repaired so water would be forced to flow through them. Alternately, they could be installed with a notch through which water could flow. I recommend that they be reinforced with wire, such as fencing material.

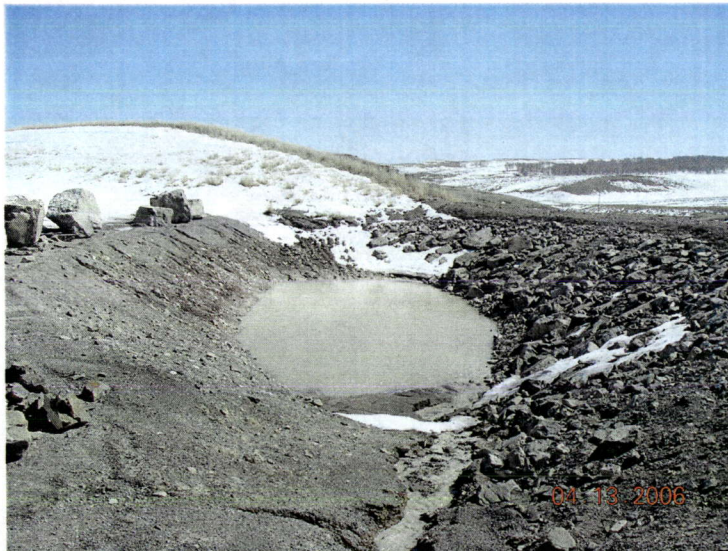
Water in the ditch on the west side of the west road was running into the sediment pond on the southwest side of the mine, and this pond appeared to be functioning properly (Photo 2).

Photo 2. Sediment pond on the southwest side of the mine.

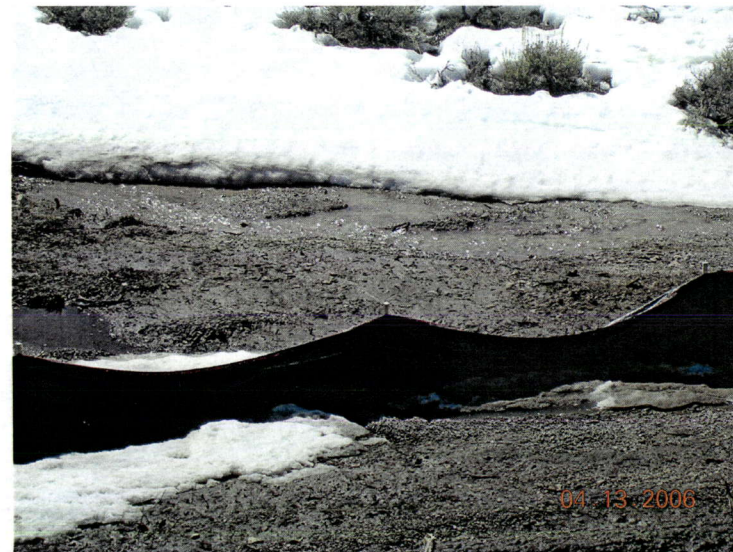
Photo 4. Another view of the silt fence below the sediment pond. Water was flowing under this silt fence.

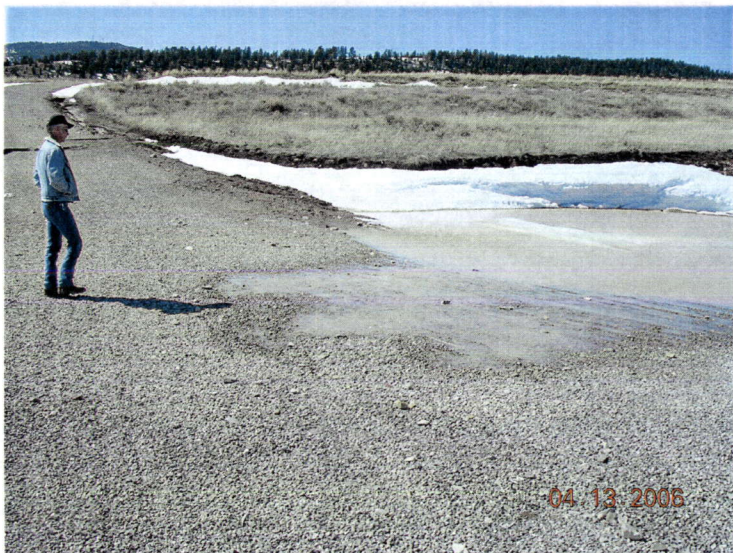
The main ditch on the east side of the mine leads to a sediment trap near the generator (Photo 5). This sediment trap was completely full of water, and it was discharging through gravel into a stream that eventually empties into Reader Creek. The sediment trap and gravel provide some treatment, but the water being discharged was brown and clearly contained more sediment than water from adjacent

Photo 5. Sediment trap near the generator on the southeast side of the mine. Water was flowing through the gravel into the area shown in Photo 6.

The sediment trap near the generator is not large enough for the amount of water that was going into it. The operator needs to either enlarge it or needed to take some other action to treat water coming from the east side of the mine. If enlarged, the resulting pond would probably need to be as large as the pond on the west side.

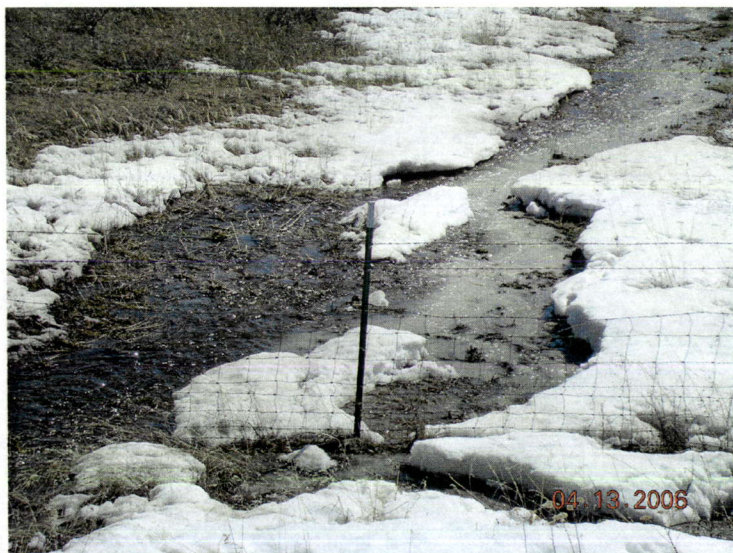
areas (Photo 6). Water on the right side of this photo is from the sediment trap, and water on the left is from undisturbed areas.

Photo 6. Water on the left is from undisturbed areas, and water on the right is from the sediment trap.

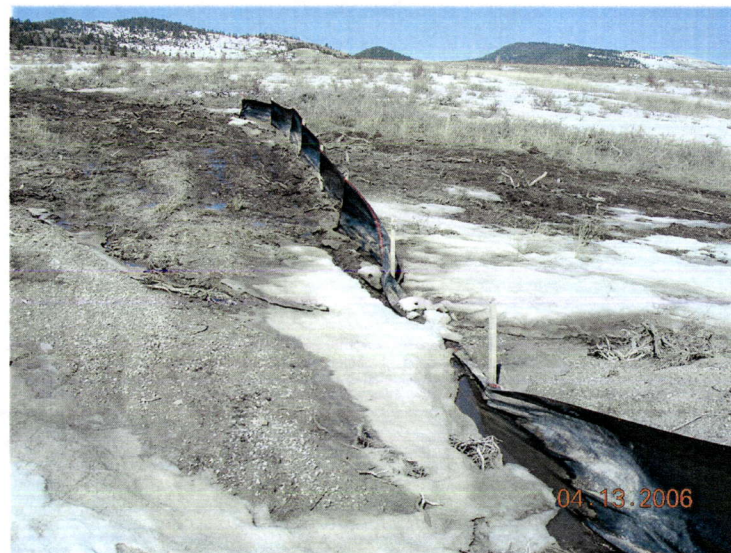
There is another silt fence toward the northwest side of the mine, and it needed repair (Photo 7).

Photo 7. Silt fence in the northeastern part of the mine.

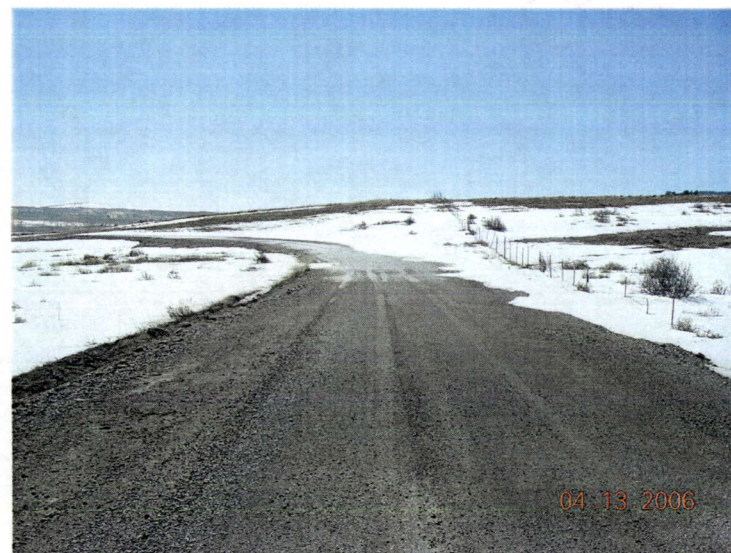
Along the access road just west of the entrance gate (Photo 8), there is a low place in the road. Water was not flowing across the road during the inspection, but with the amount of water that has impounded north of the road and the amount of snow still to melt, we anticipate the road will be overtopped.

Photo 8. I suggest the operator consider putting a culvert under the entrance road.

I recommend that a culvert be installed under the entrance road (unless one is already there and I couldn't see it for the snow).
